Electrochimica Acta

Initial stages of localized corrosion at cut-edges of adhesively bonded Zn and Zn-Al-Mg galvanized steel

The mechanisms of the initial stages of localized corrosion at cut edges were investigated for adhesively bonded Zn (Z) and Zn-Al-Mg (ZM) galvanized steel. The results provided strong evidence for the localized nature of corrosion of galvanized coatings at the cut edges and at the adhesive/zinc interface. In both cases a defined localized corrosion attack on zinc in Z sample was observed. On the contrary, in the case of the ZM specimen both zinc solid solution and eutectics exhibited local corrosion. The local attack at the adhesive/Z(ZM) interface was correlated with an anodic undermining process. It develops near the cut-edge surface and at the buried deep adhesive-zinc interface and results in adhesive disbonding in the buried interface. The electrochemical studies revealed that the corrosion kinetics at the metal cut-edges decreases during immersion, which could be due to formation of corrosion products on both steel and zinc surfaces.

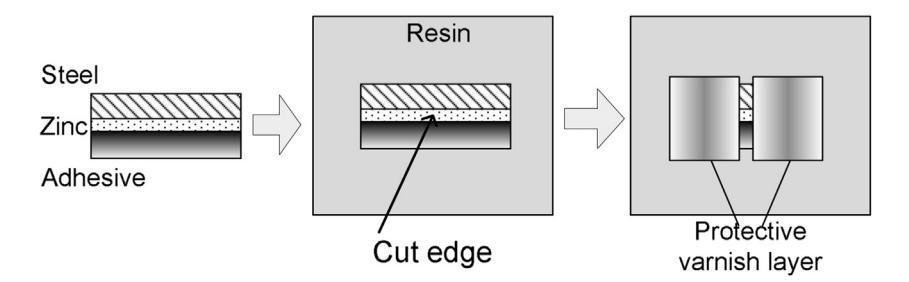
Fig. 1. Schematic representation of the cut-edge of adhesively bonded galvanized steel.

The adhesive has been applied onto the galvanized steel substrates by squeezing adhesive on the centre of a steel sample strip. Afterwards the samples were covered with a TeflonTM sheet and pressed with a mechanical press at a pressure around 3-5 bars. The adhesive thickness was around $250 \,\mu\text{m}$ and was controlled by hardened steel spacers during the adhesive application and pressing procedure. The prepared samples were cured during 20 min at 170 °C. The sample temperature was monitored by a thermocouple touching the metal surface. The prepared samples were cut into 1 cm² pieces and the zinc coating from the side opposite to the adhesive layer was eliminated with SiC paper in 2propanol. The adhesively bonded samples were embedded in mounting resin (as indicated in Fig. 1). A side perpendicular to the adhesive/zinc/steel sandwich was abraded down to 4000 grit SiC sand paper and then polished using oil based diamond pastes down to 1 µm. The samples were cleaned after polishing in 2propanol in ultrasonic bath during 5 minutes and dried in a flow of warm air. Prior to investigation the samples were etched in 0.5 wt. % solution of nitric acid in ethanol during 1 second and then immediately washed in 2-propanol and dried in order to reveal the microstructure of the polished cut-edges and to remove possible layers of deposits from the surface. A protective varnish was applied on the other sides of the sample in order to confine the exposed area (Fig. 1).

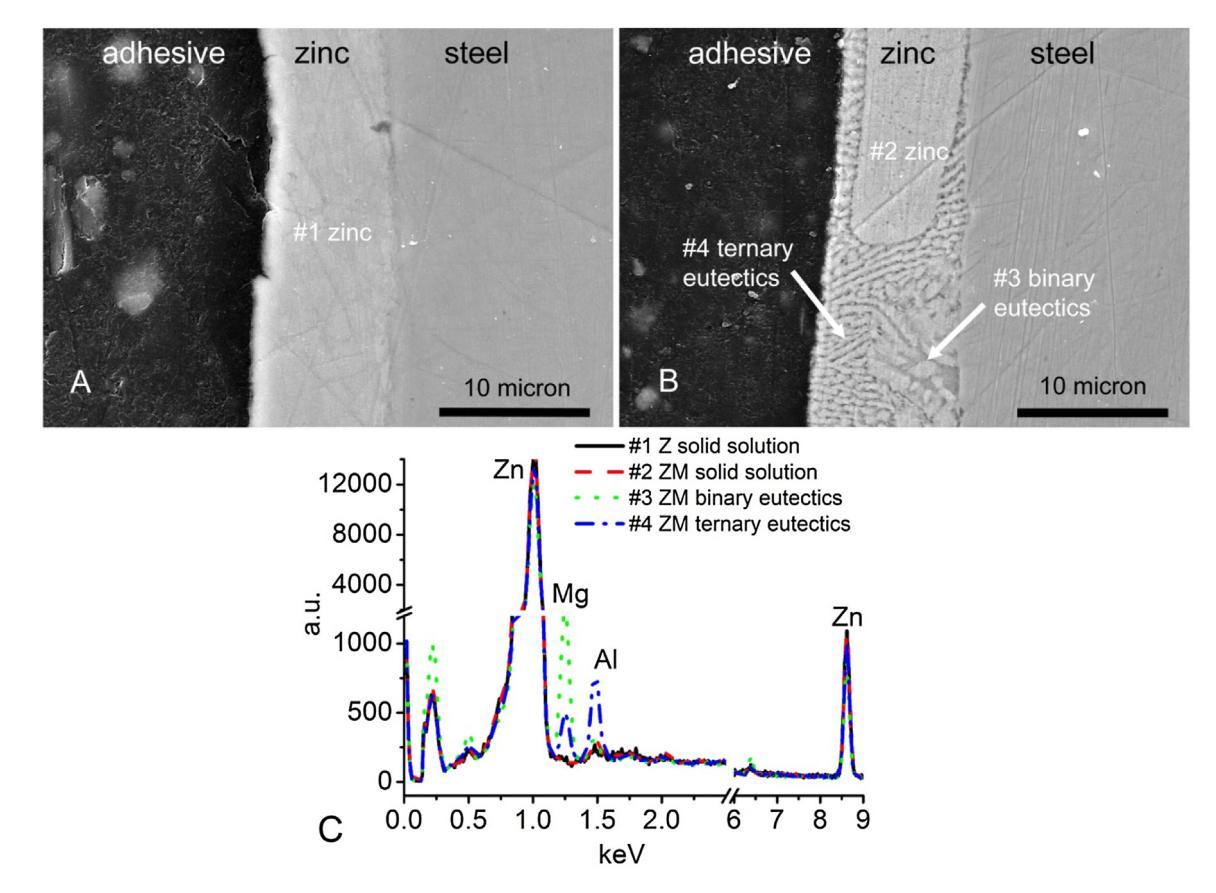
Fig. 2. SEM micrographs of Z (a) and ZM (b) adhesively bonded galvanized layer cut-edges and EDS spectra (c) of the selected regions on both micrographs.

The microstructure of the Z and ZM cut-edges is shown in Fig. 2. Zinc coating on Z sample has a thickness around $7-9 \,\mu\text{m}$. The bulk zinc matrix shows a uniform contrast in SEM maps. The interface between zinc and steel is enriched with Al. Its composition can be described as Al₅Fe₂ [34]. This layer inhibits the diffusion of iron to the zinc rich layer and the formation of iron containing phases [35]. The zinc solid solution phase on the Z sample is mainly composed of Zn (Fig. 2c). The ZM cut-edge demonstrates different microstructure compared to Z one. The SEM micrograph of ZM sample shows several zones having different contrast and microstructure in the zinc layer (Fig. 2b). The zinc solid solution phase can be identified in the bright places (Fig. 2b,c #2). The zones which have a somewhat darker contrast (Fig. 2b #3,4) are composed of a binary or ternary eutectic solution of zinc, aluminium and MgZn₂ [7,13]. The binary eutectics have larger MgZn₂ lamellas compared to ternary eutectics (Fig. 2b). EDS can clearly show the difference in intensity between the Mg peak and the Al one on the spectra acquired on binary and ternary eutectics (Fig. 2c #3,4).

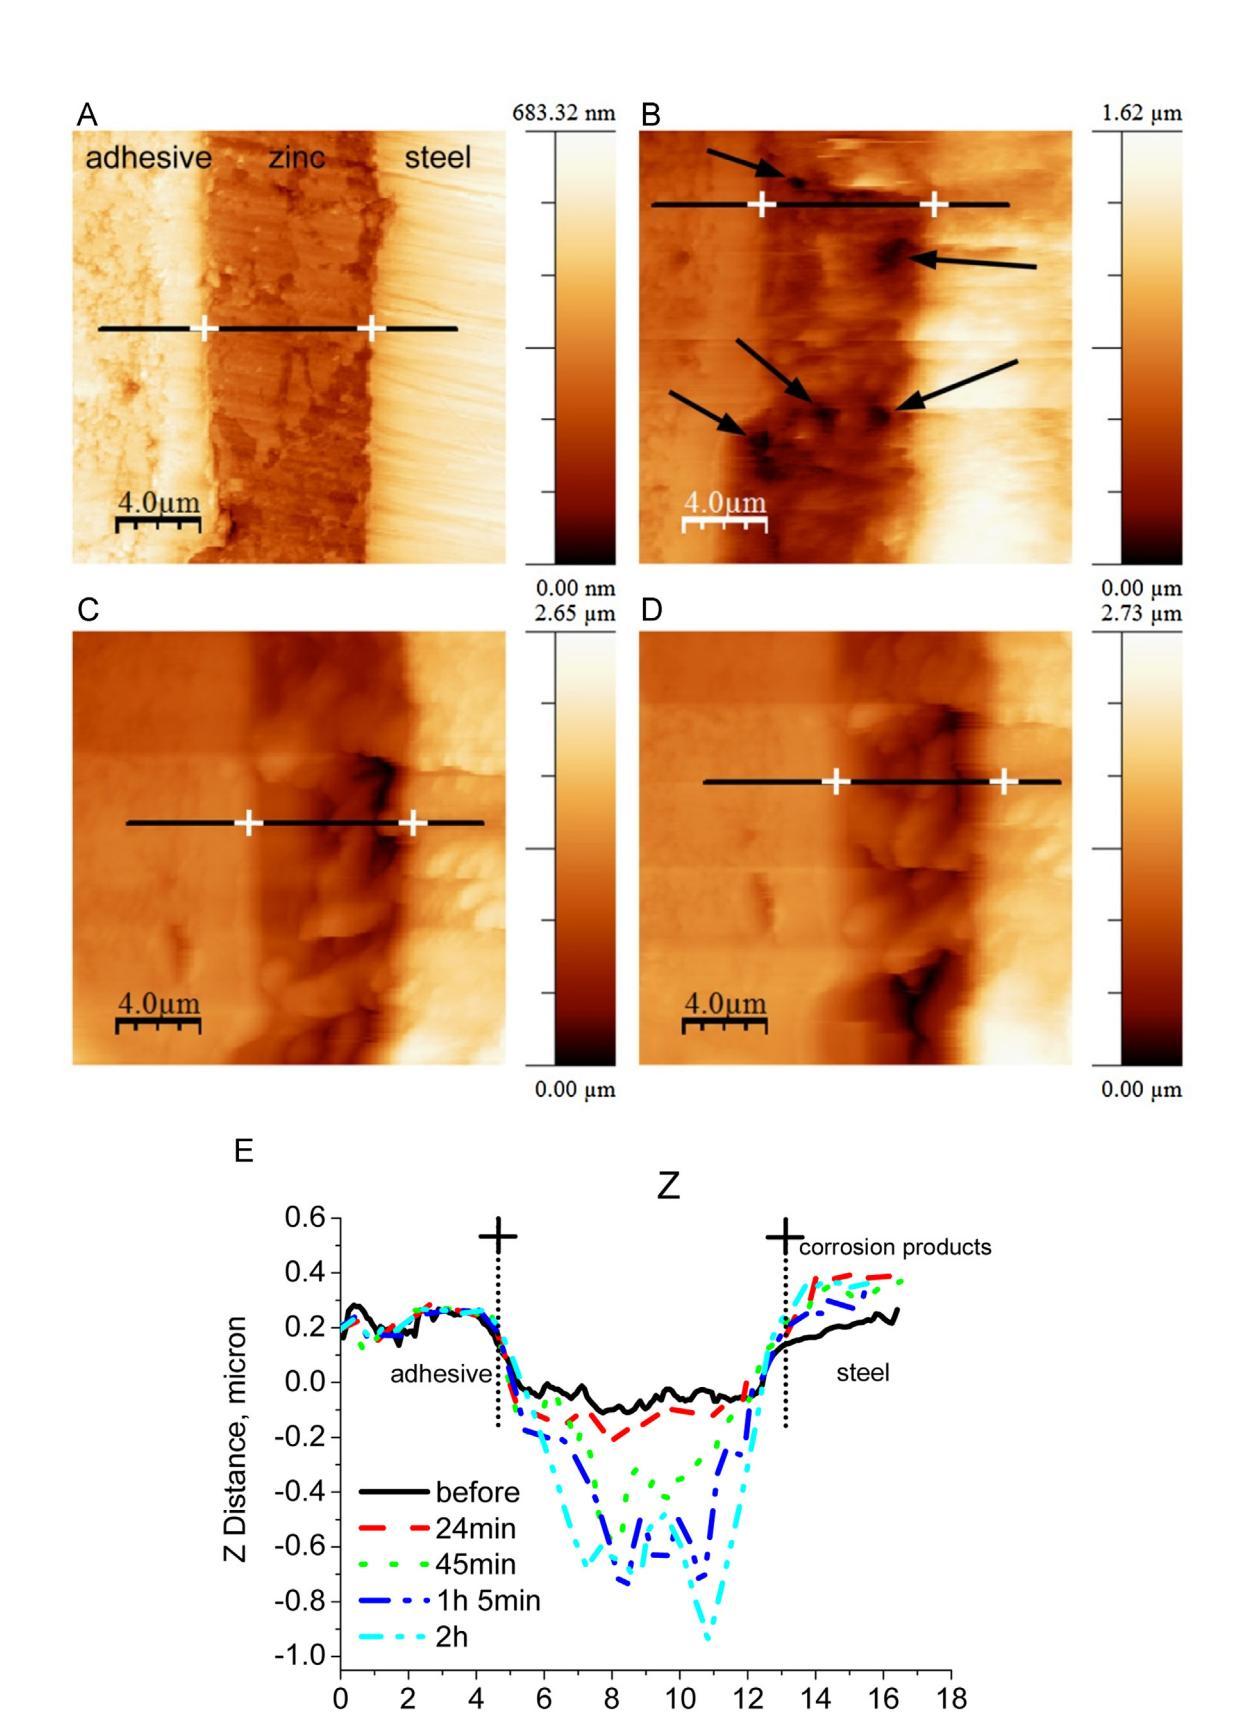
Fig. 3. AFM topography maps made on cut-edge of adhesively bonded Z substrate before immersion (a) and during 24 min (b), 1 h 5 min (c), and 2 h (d) immersion in 0.001 M NaCl; figure (e) presents evolution of topography across the black lines profiles drawn in the same zones on AFM maps. Black arrows indicate local pits on zinc layer. AFM images show adhesive on the left side, zinc in the middle and steel on the right.

In situ AFM measurements were done during immersion in 0.001 M NaCl solution in order to characterize the initial stages of the corrosion attack. A low concentration of NaCl solution was chosen since the zinc laver degradation rate at higher NaCl concentrations was too fast. Fig. 3 presents topography maps and profiles acquired on the Z sample cut-edge surface before immersion (a) and during immersion (b,c,d) in NaCl solution. The maps show three distinct regions ascribed to adhesive, zinc and steel (from left to right). The polishing procedure caused some overpolishing of softer zinc surface with respect to more hard adhesive and steel parts (Fig. 3a). After addition of electrolyte in a liquid cell the corrosion process had quickly initiated in some particular zones on the zinc layer. The shiny zinc layer before immersion quickly turned black during the in situ tests (not shown). This indicates the rapid corrosion process occurring during immersion. Such changes can be attributed to dissolution of metal and formation of a corrosion product layer at the beginning of immersion. The AFM map acquired after 24 min of immersion depicts dissolution of the zinc matrix and formation of small pits up to 1 µm deep, marked by black arrows on the image (Fig. 3b). During immersion the dissolution depth was progressively increasing deeper into the zinc layer (Fig. 3c,d,e). The maximal dissolution depth at the end of the immersion was around 1 μ m as indicated on profiles Fig. 3c,e. However, in some other places of the maps the trench depth could reach around $1.5 \,\mu m$ (see the bottom of the image). Fig. 3d. The changes in topography suggest that pits form on the zinc surface in some active spots.

polarisation started. The AFM map (upper part) revealed an immediate localized pitting corrosion of the Z surface after the polarisation was applied. The shape of the formed pits is similar to those found on the Z cut-edge (Fig. 3). During immersion, the local pits grow deeper into the zinc surface (Fig. 5e). At longer immersion time (>30 min) the zinc surface shows more corrosion spots and presents visible dissolution of metal matrix (not shown).

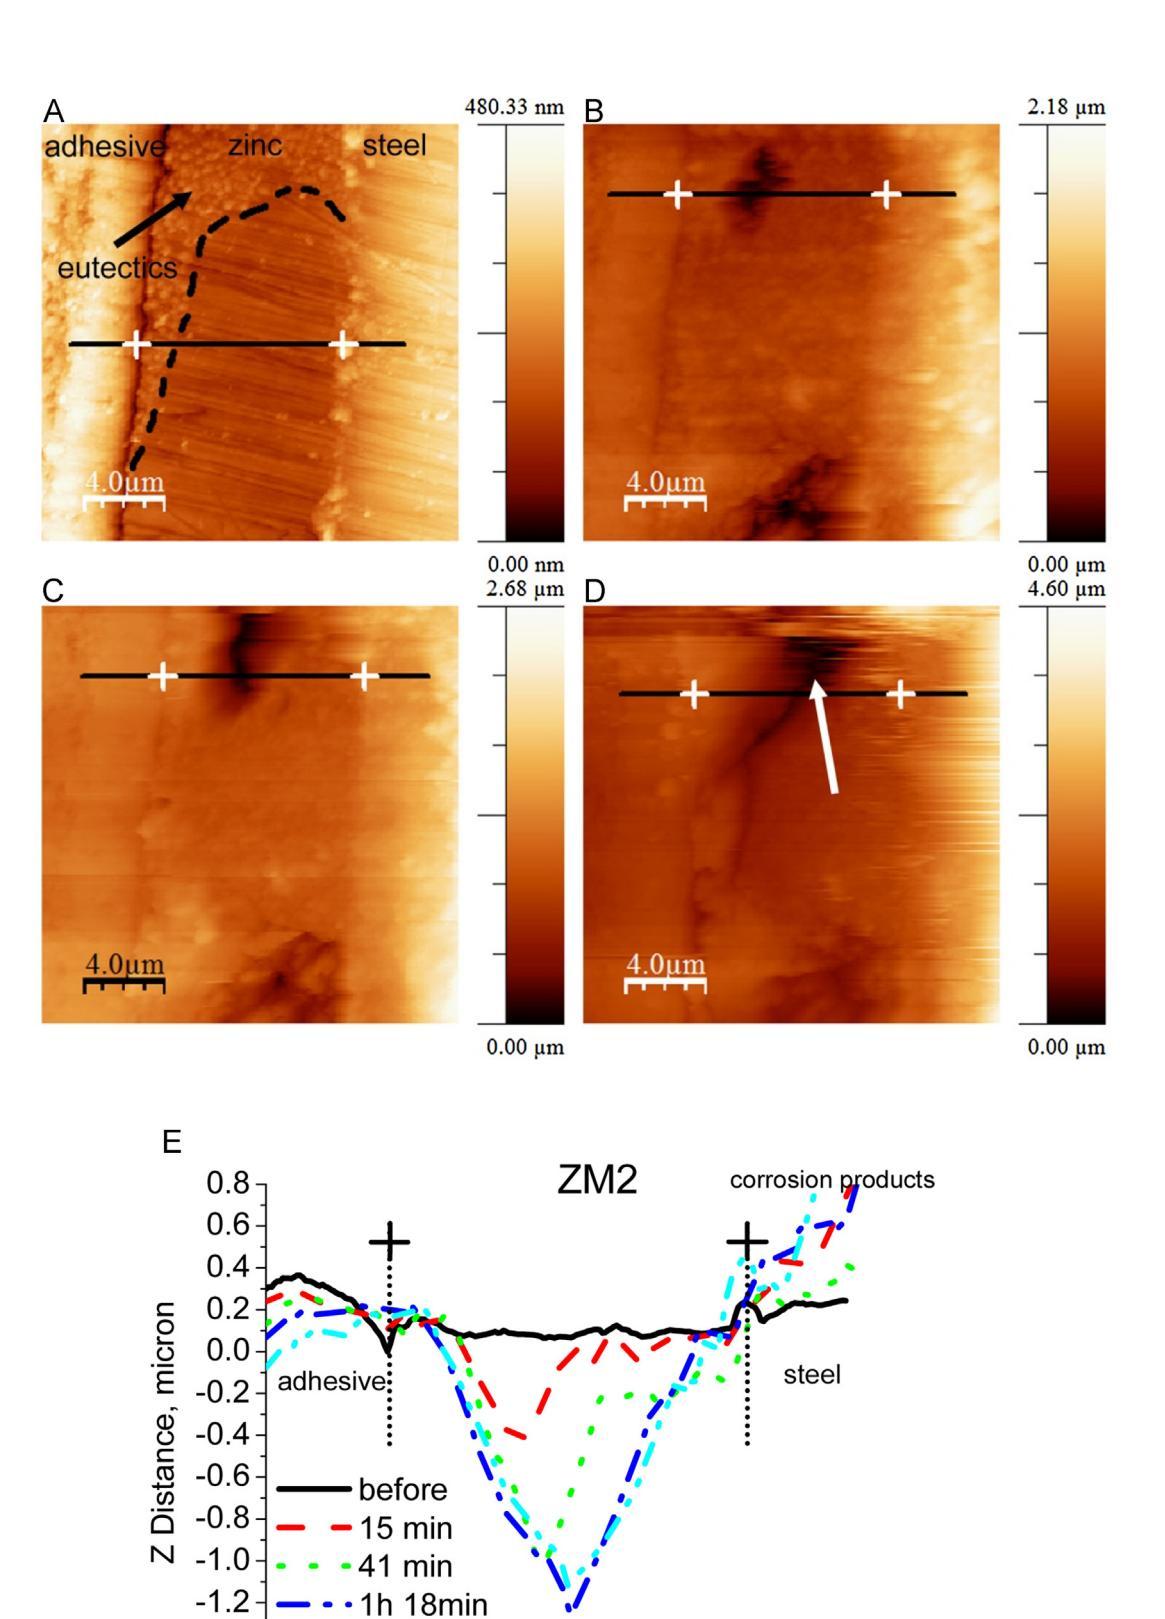
Fig. 4. AFM topography maps made on cut-edge of adhesively bonded ZM substrate before immersion (a) and during 15 min (b), 41 min (c) and 2 h 08 min (d) immersion in 0.001 M NaCl; figure (e) presents evolution of topography across the black lines profiles drawn in the same zones on AFM maps. Arrows indicate local pits in zinc layer. AFM images show adhesive on the left side, zinc in the middle and steel on the right.

In situ AFM measurements on the ZM cut-edge were performed in a similar fashion as for Z sample. The first topography map

shows the ZM substrate cut-edge before exposure to NaCl solution (Fig. 4a). The surface topography shows a zone indicated by an arrow (Fig. 4a), which is attributed to the ternary eutectic phases. The microstructure of this zone is very similar to the one that corresponds to the ternary eutectics (Fig. 2b). The zinc solid solution zone is located below the contour line (Fig. 4a). The black line profiles on the AFM maps before (Fig. 4a) and during (Fig. 4b.c. d) in situ measurements identify the same zone on these maps. During short term in situ immersion a rapid localized corrosion process started on the zinc layer of the ZM sample. After 15 min of immersion the map shows two local pits on the surface (Fig. 4b). The local corrosion process initiated near the eutectic zone in the upper part of the image while the second local corrosion process developed on a zinc solid solution zone in the bottom part (Fig. 4b). The AFM map presented in Fig. 4b and topography profiles on Fig. 4e demonstrate that the corrosion products precipitate on steel surface on the right part of the investigated area. This is consistent with the fast corrosion process developed on the cut-edge. The pits in the Zn layer represented by a darker zone in the upper and lower parts of the topography images are growing continuously (Fig. 4b,c, d). At longer immersion time the corrosion process progressed through the Zn matrix and a deeper trench more than 1.5 µm (shown by an arrow) formed (Fig. 4d,e). Dissolution of the zinc layer continued at longer immersion time in the galvanized layer close to adhesive/zinc interface (Fig. 4d). It should be noticed that the eutectic zone close to the adhesive has been slightly corroded by the end of immersion (Fig. 4d). Initially, the topography across the zinc cut-edge surface was flat and by the end of immersion the topography became rough and uneven (Figs. 4a.d). However, the topography profiles presented in Fig. 4e did not show pits on the eutectic zone close to adhesive.

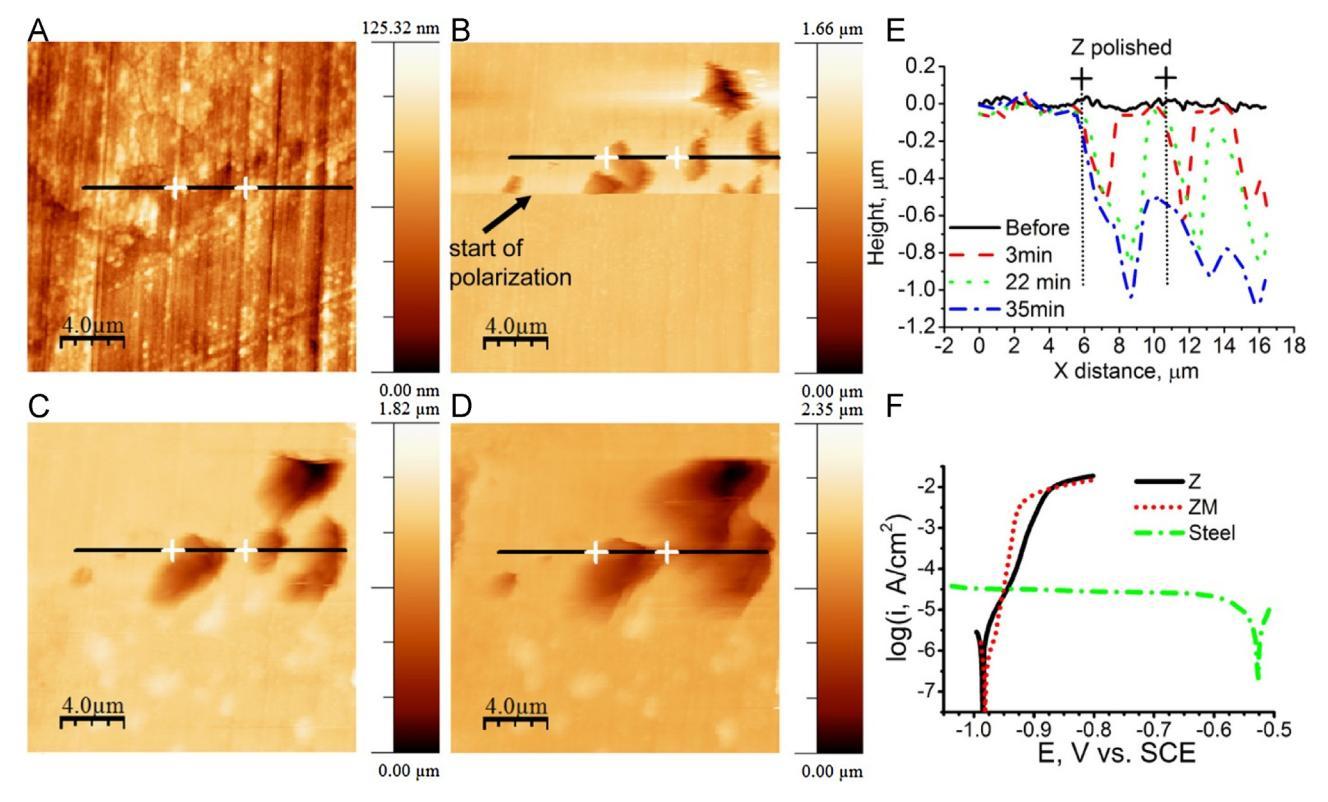
Fig. 5. AFM topography maps of polished Z galvanized coating before immersion (a) and during immersion in 0.005 M NaCl: 3 min (b), 22 min (c), 35 min (d); figure (e) presents evolution of topography across the black lines profiles; figure (f) presents cathodic polarization curve on steel and anodic polarisation curves on Z and ZM samples.

For these experiments, Z and ZM galvanized coatings were polished to approximately $1-3 \mu m$ in depth. The polished surface was microstructurally similar to the layer of zinc at the cut-edges. In order to cause anodic dissolution of the zinc coatings, a potential of +40 mV vs. corrosion potential of the sample was applied. This potential difference was similar to the polarisation of zinc coatings by steel as follows from the polarisation measurements presented in Fig. 5f. The intersection between the polarisation curves made on steel and polished zinc coatings is located approximately 40 mV above the corrosion potential of the Z and ZM galvanizing coatings (Fig. 5f).

Evident metal dissolution of the metal matrix can be seen on the AFM map after 4 min of polarisation (Fig. 5c). The AFM topography profiles before and during the immersion were levelled relatively to the zero level located on the uncorroded zinc surface (Fig. 6f). These profiles show visible dissolution of eutectic phases and also local corrosion attack at the zone of zinc solid solution (Fig. 6f). The topography map presented in Fig. 6d clearly shows corrosion of both the eutectic zone and local corrosion of the solid solution zone. However, the dissolution process is not progressing uniformly on the zinc solid solution zones. After 16 min of immersion the dissolution of zinc solid solution becomes visible on the left side of the image (Fig. 6e,f). With longer immersion (22 min) the AFM profile shows evidence of zinc solid solution dissolution on the right side (Fig. 6f).

Localized pitting attack has also been found during in situ AFM measurements on the model polished galvanizing coatings under anodic polarisation. The Z sample revealed similar localized pitting attack as in the case of cut edge corrosion (Figs. 3 and 5). On the other hand, both the ternary eutectic phases and the zinc solid solution underwent a corrosion attack on the ZM sample (Fig. 6). The corrosion locus was located on the eutectic phases and at the interface between eutectics and solid solution zones, similar to what was found on ZM cut-edge (Figs. 4 and 6). Polarisation curves recorded for model Z and ZM samples show low anodic slopes suggesting high zinc corrosion rate during polarisation (Fig. 5f).

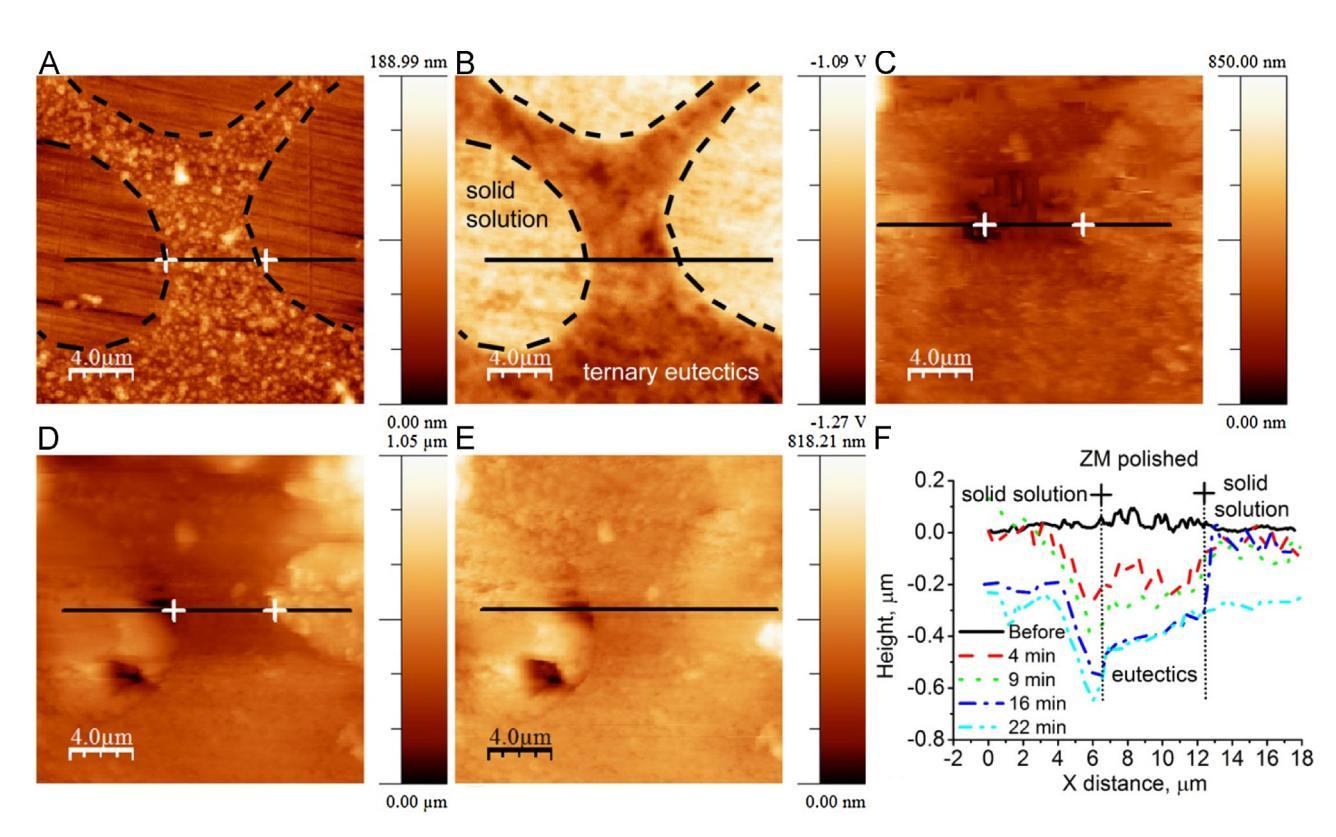
Fig. 6. AFM topography (a) and SKPFM (b) maps of polished ZM galvanized coating before immersion and during immersion in 0.005 M NaCl: 4 min (c), 9 min (d), 22 min (e); figure (f) presents evolution of topography across the black lines profiles.

The localized corrosion activity of the ZM sample on a selected zone is presented in Fig. 6. The location before immersion is shown on the topography and Volta potential maps in Fig. 6a and b respectively. The area in the middle of the images is attributed to ternary eutectics region. This place has lower Volta potential level (dark area) compared to the surrounding zone of zinc solid solution separated by contour profiles (light area), Fig. 6b. Moreover, the analysis of such area after corrosion by SEM/EDS (not shown) has confirmed the presence of Al in the eutectic zone. Therefore such zone can be correlated with ternary eutectic.

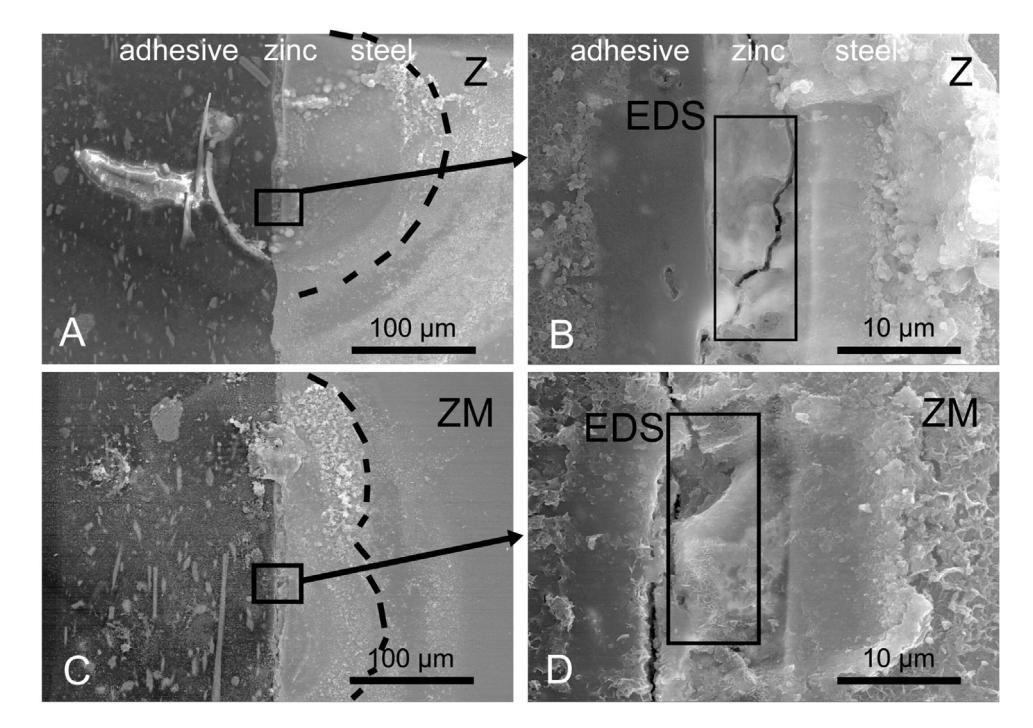
Fig. 7. SEM micrographs of Z (a,b) and ZM (c,d) cut-edges after in situ AFM measurements.

3.2.3. SEM/EDS characterisation of the cut-edge surface after corrosion The images (Fig. 7a,c) show general view of the Z and ZM cutedges after corrosion. Semicircle contour lines demonstrate the distribution of corrosion products along the steel surface with the anodically active zinc layers located nearby. AFM measurements

were performed on the anodically active zones shown by black squares (Fig. 7a,c). Fig. 7b,d presents zoomed regions of cut edge surface where AFM measurements were performed. The surface of zinc layer reveals well defined corrosion attack. SEM images also display several cracks on the corroded zinc layer and near the adhesive/zinc interface after corrosion (Fig. 7b,d). Most probably mechanical stresses developed inside the corrosion products layer during drying of the samples in air or in the SEM chamber inducing the contraction of corrosion products and, consequently, the appearance of cracks. The inspection of other regions along the zinc cut-edge also showed cracks in various parts of the corroded zinc layers in Z and ZM samples (not shown).

The EDS analysis of the corroded cut-edge zones (Fig. 7b,d) revealed the decrease of Zn and Mg (in the case of the ZM sample) and the increase of Cl, O and Al signals intensity with respect to the uncorroded zones (not shown). The changes of the at.% of different elements are presented in Table 1. The EDS spectra did not reveal any measurable Mg levels on the corroded ZM cut-edge. This confirms that Mg-rich phases dissolve during the cut-edge immersion. On the other hand, the Al signals have increased on Z and ZM samples after corrosion (Table 1). Such increase may be caused by enhanced stability of Al-containing phases towards the

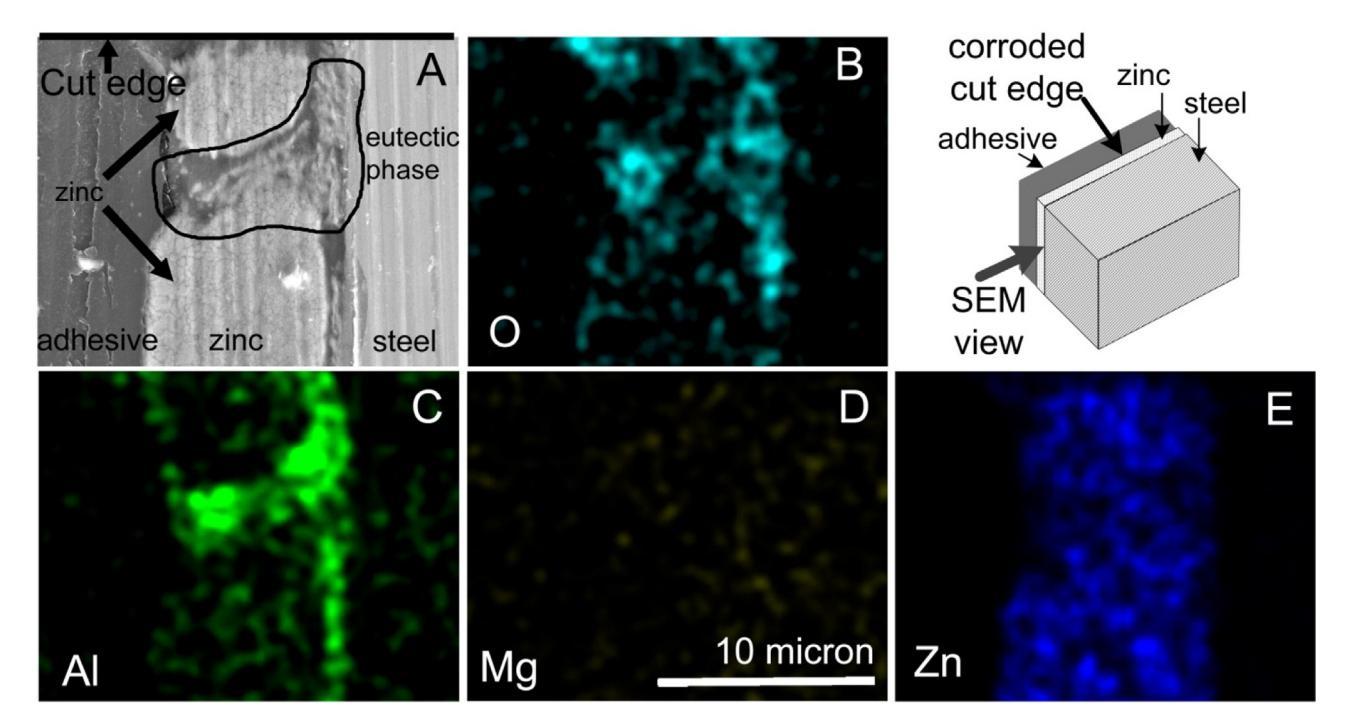
Fig. 8. SEM micrograph and maps of O, Al, Mg and Zn elements of ZM cut-edge immersed for 2 hours in 1 mM NaCl. Ternary eutectic region is highlighted by a black line. The SEM observation plane is schematically presented on the right inset scheme.

An additional analysis of the ZM cut edge after corrosion has been done to clarify details of the eutectic phase corrosion. SEM and EDS maps were acquired on the ZM samples perpendicular to the plane of the cut-edge as depicted on the sketch (Fig. 8). The SEM micrograph denotes the eutectic zone in the middle highlighted by a contour line and two zinc solid solution zones located in the top and bottom parts of the image. The composition of the solid solution zone was similar to that presented in Fig. 2c (zone #2). The corroded eutectic zone was ascribed to ternary eutectics which had similar composition as the zone #4 indicated in Fig. 2c. The eutectic zone appears to be significantly corroded compared to the zinc solid solution zones. This correlates with the increase of the O signal and the absence of Mg signal as shown in Fig. 8b,d. The absence of Mg clearly demonstrates the selective dissolution of this element from the eutectic phase. On the other hand, Zn lamellas stayed relatively intact inside the ternary eutectic region (Fig. 8e). The EDS analysis also demonstrates the accumulation of Al and O signals in the eutectic zone (Fig. 8c). This evidences the formation of corrosion products in the eutectic phase.

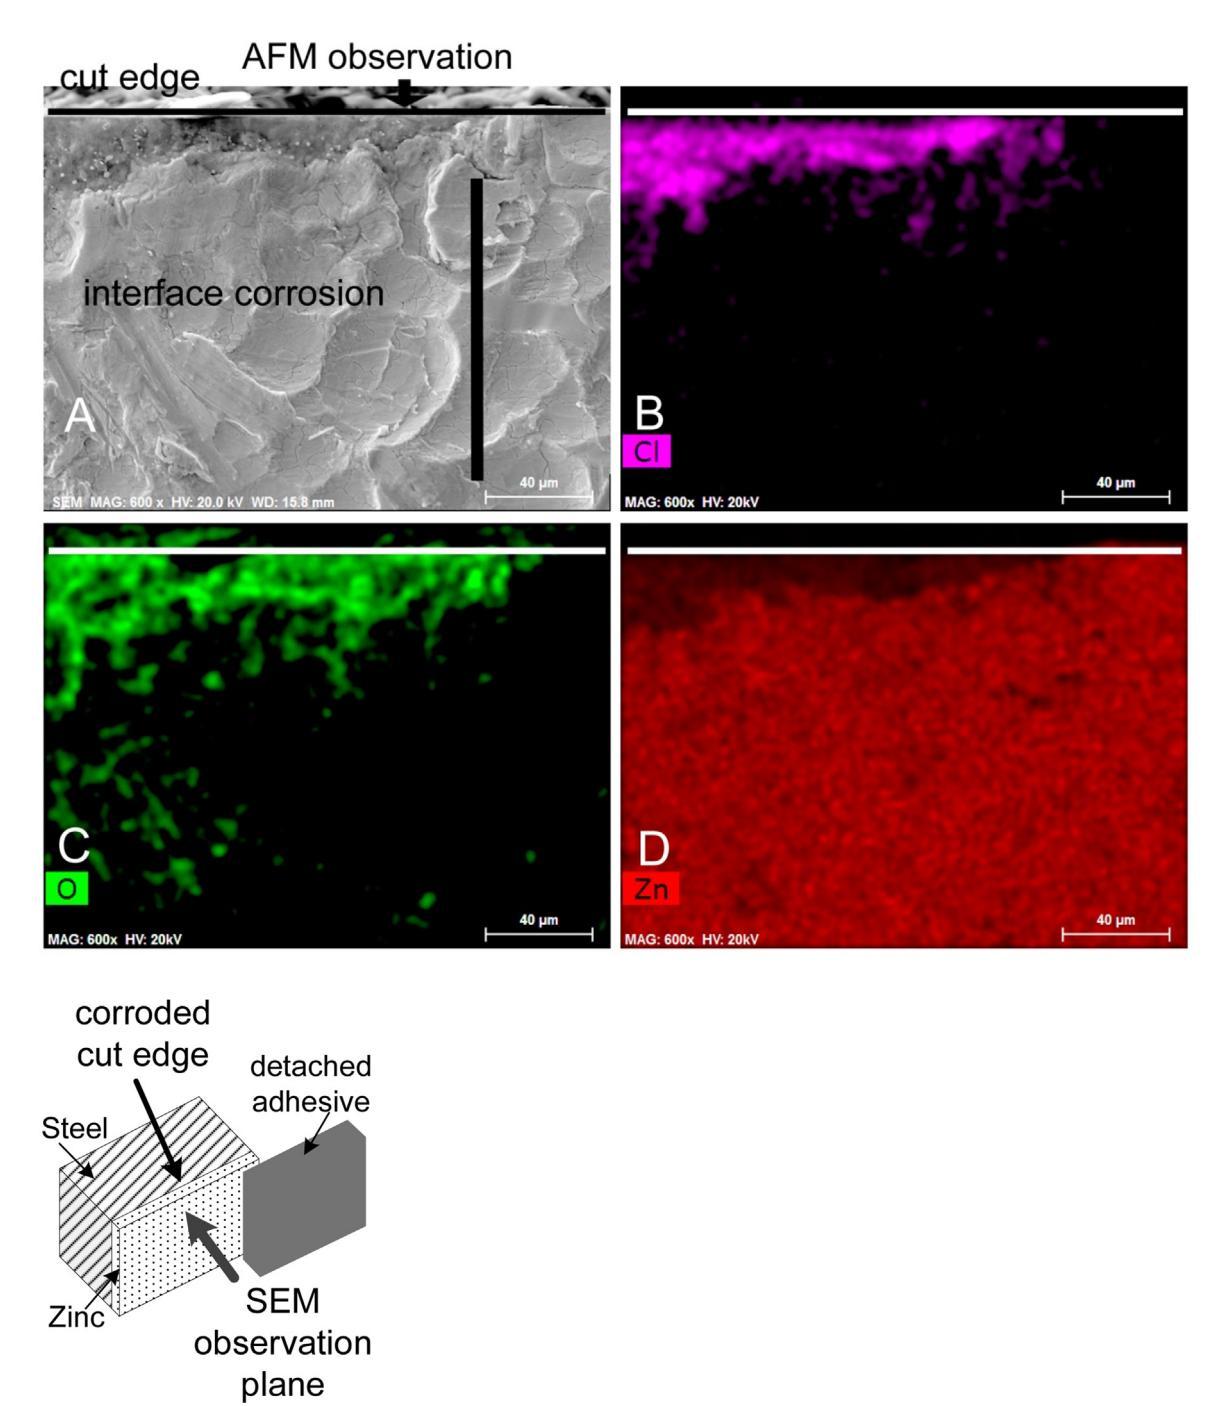
Fig. 9. SEM and EDS maps of the corroded Z sample zinc surface after adhesive removal. The SEM observation plane is schematically presented on the sketch.

have been done. Figs. 9 and 10 present SEM images and EDS maps acquired on the Z and ZM galvanizing coating interface after the adhesive was detached as was shown on the sketch. After immersion, the zinc coatings close to the cut-edge were locally corroded to a depth about $20-30 \,\mu\text{m}$ on both the Z and ZM samples (Figs. 9 and 10). The corrosion zone can be correlated with the depletion of zinc (Fig. 9d). On this zone the EDS revealed high concentration of Cl and O elements (Figs. 9b,c and 10b,c). In some areas O and Cl signals may be found to a depth about $80 \,\mu\text{m}$ demonstrating that the corrosion process may significantly extend in the buried zinc adhesive interface. This evidently shows that corrosion products can form at a high depth from the cut-edge.

Microstructural analysis has also revealed an initial localized corrosion at the zinc-adhesive interface as indicated in Figs. 9a, 10a. Fig. 11 presents the uncorroded (a,b) and corroded zinc coatings of Z and ZM cut-edges (c,d) after adhesive removal. The pictures of the corroded surface were acquired at the depth about 50–60 μ m from the cut-edge surface. After corrosion the Z

The microstructural observation of the galvanizing coating surface after adhesive removal has revealed that the zinc layer near the cut-edge surface was substantially corroded to a depth about 20–30 μ m (Figs. 9 and 10). This corrosion zone was attributed to the first disbonding zone between adhesive and metal. Moreover, a superficial localized dissolution of both zinc solid solution and eutectics was additionally revealed at zinc/ adhesive interface (Fig. 11). The second disbonding zone has been identified at the buried adhesive/zinc interface. The localized attack at the interface can be found preferably below highly active anodic places at the cut-edge. Figs. 9a,c and 10a,c show a high O signal below the cut edge surface and reveal the zone where the localized attack at the interface is found. On the contrary, interface corrosion has not been found below the inactive cutedge surface which did not show any anodic dissolution. Such intact zinc/adhesive interface zones can be seen at the right part of Fig. 9 or the left part of Fig. 10.

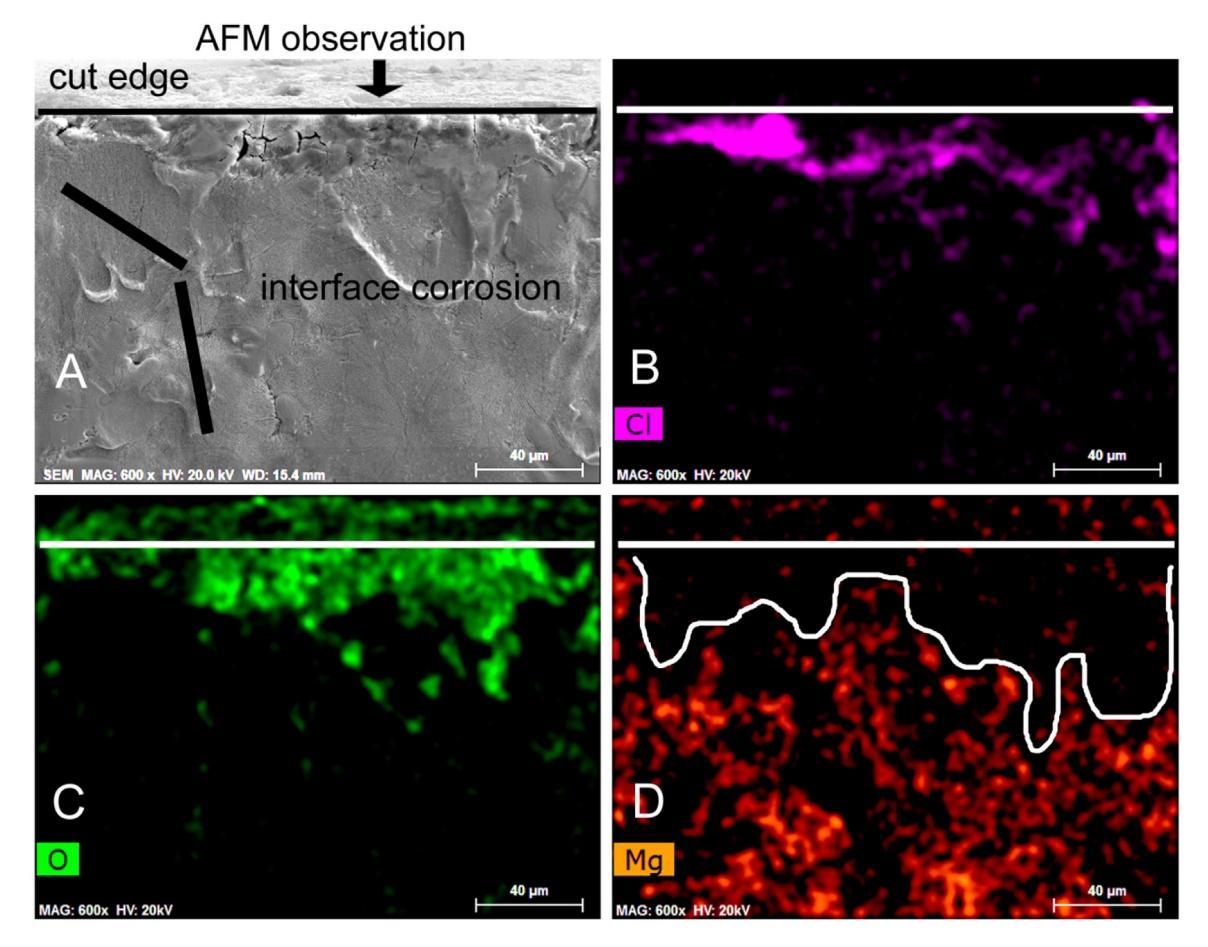
Fig. 10. SEM and EDS maps of the corroded ZM sample zinc surface after adhesive removal. The SEM observation plane is the same as indicated in Fig. 10.

Moreover, Mg signal could not be detected on a large distance from the cut edge on the ZM sample (Fig. 10d). Consequently, such depletion reflects the higher corrosion susceptibility of the eutectics at the adhesive/zinc interface. These results indicate a deeper corrosion attack compared to what was observed at the cut edges by in situ AFM and SEM/EDS.

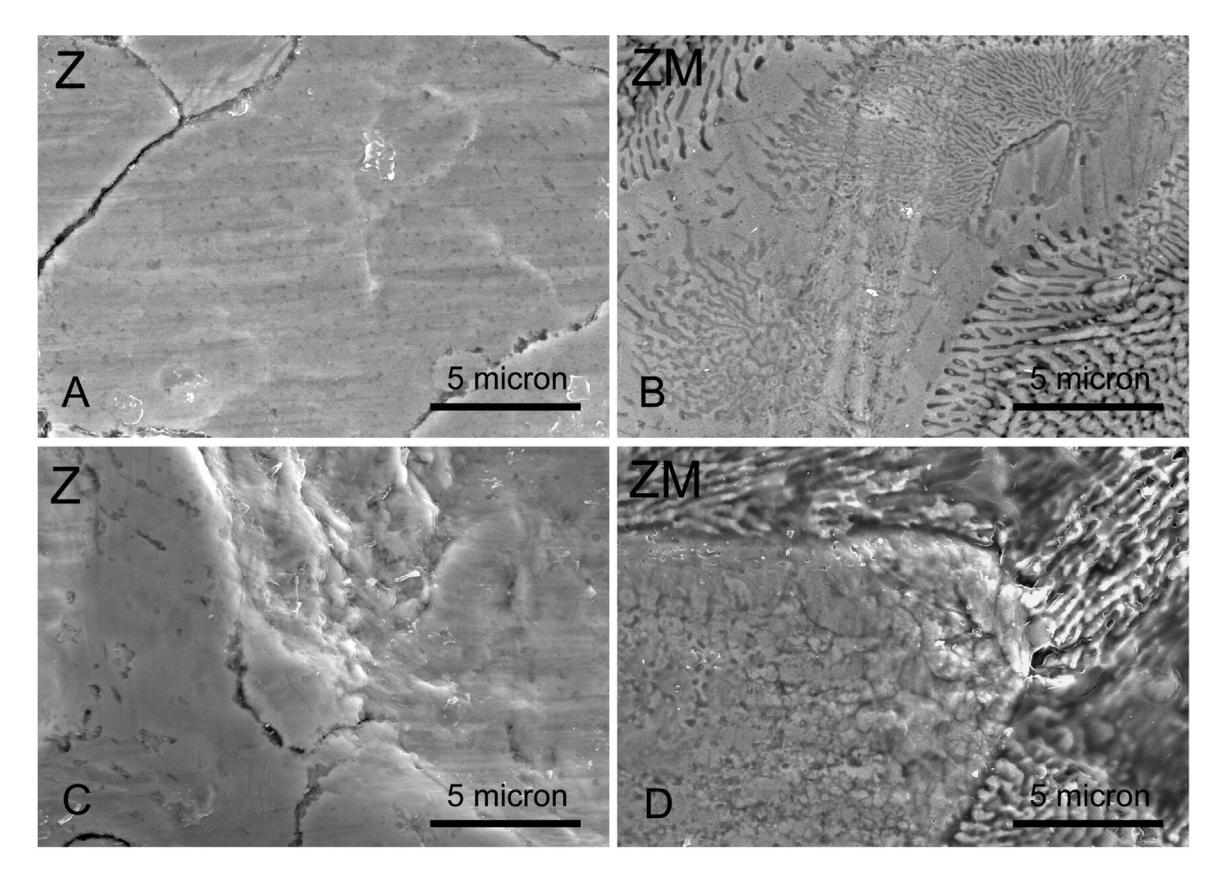
Fig. 11. SEM images of uncorroded Z (a), ZM (b) zinc surface and corroded zinc-adhesive interface Z (c) and ZM (d) after adhesive removal.

galvanized surface depicted local dissolution zones found on both zinc grains and grain boundaries (Fig. 11c). On the other hand, local corrosion attack was revealed on both eutectic and zinc solid solution regions on the ZM sample (Fig. 11d).

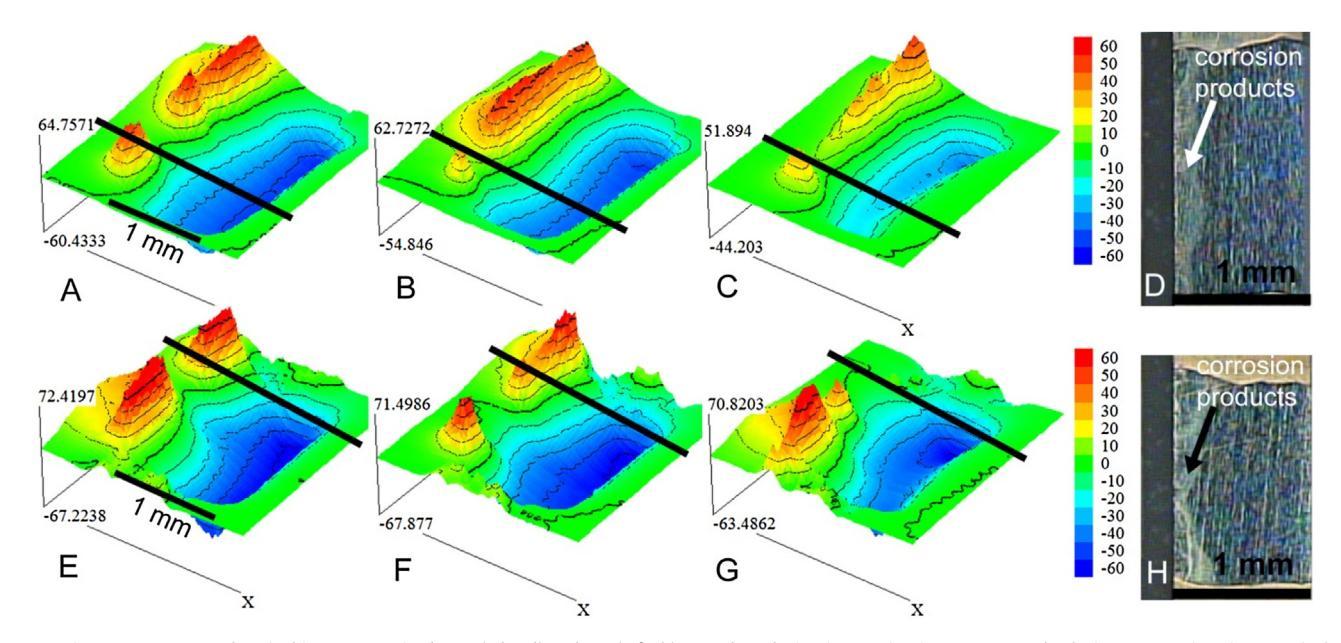
Fig. 12. Ionic current maps and optical images acquired on Z (a.b.c.d) and ZM (e,f,g,h) cut-edges during immersion in 0.001 M NaCl solution. Immersion time; 5 min (a, e), 1 hour (b, f), 2 hours (c, d and g, h); the ionic currents are in the units μ A/cm².

seen that the total ionic currents generated on the ZM sample are higher than on Z one, which suggests a slightly higher corrosion activity of the ZM sample. In both cases the activity decreases with the immersion time. A more detailed analysis of the localized corrosion behaviour on the Z and ZM cut-edges is presented in Fig. 13b. The figure shows evolution of the current profiles drawn through the black lines as indicated in Fig. 12. It can be seen that the anodic activity on zinc significantly decreases with time (Fig. 13b). However, the steel area close to the zinc edge shows high levels of cathodic activity (Fig. 13b). Therefore a sudden anodic current decrease may be consistent with the deposition of a corrosion products layer on zinc as it was shown in Figs. 7b,d, 9, 10. Such layer may locally block the zinc dissolution thereby reducing anodic ionic currents as was shown on SVET ionic current maps and current profiles (Figs. 12 and 13b).

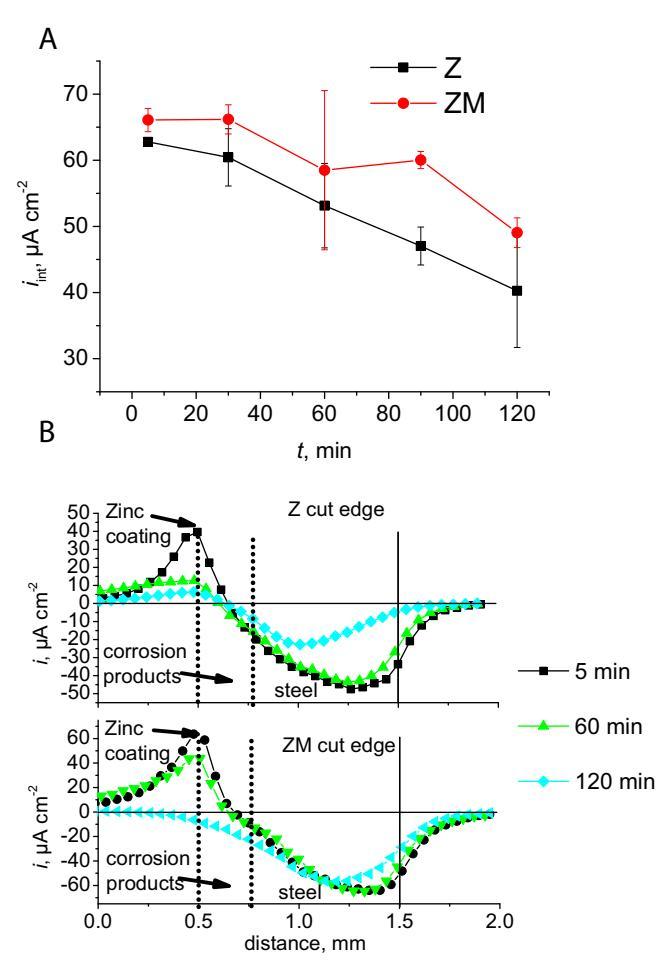
Fig. 13. Integrated total ionic currents activity (a) and ionic current profiles (b) on Z and ZM samples cut-edges acquired through black profiles shown in Fig. 12.

In evaluation of the corrosion kinetics, it is more convenient to present the integrated SVET current values normalized per unit of area of metal. Both anodic and cathodic currents were integrated in order to find the total ionic current activities and show the evolution of the corrosion kinetics over time (Fig. 13a). It can be

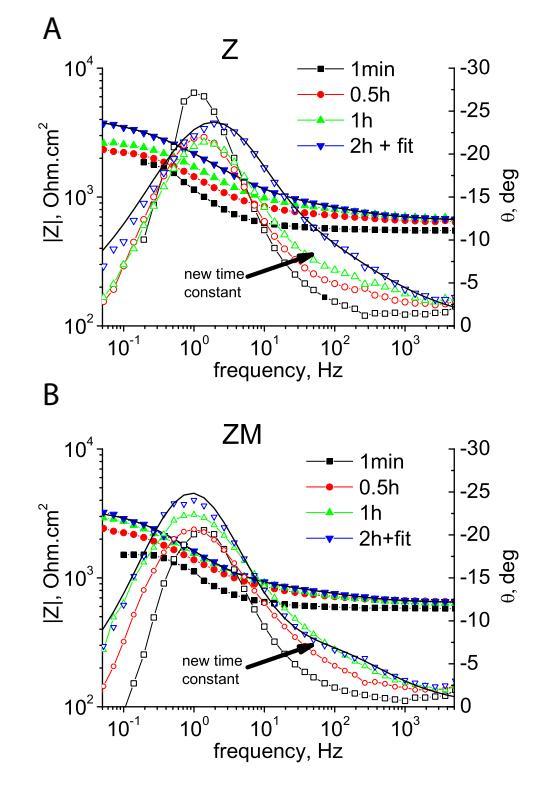
Fig. 14. EIS spectra of Z and ZM cut-edges during immersion in 1 mM NaCl.

The impedance spectra of the Z and ZM cut-edges during immersion are presented in Fig. 14. The initial impedance spectra show one clear time constant at low frequencies. This relaxation process is attributed to polarisation resistance and double layer capacitance, which represents an active corrosion process on a cut-edge. In addition, a new time constant appears on the spectra at higher frequencies during immersion (Fig. 14). This time constant has become more defined by the end of 2 hours of immersion and it can be attributed to a growth of corrosion precipitates on the cut-edge surface. The impedance spectra after 2 h of immersion were fitted with an equivalent circuit composed of two time constants in cascade. The model describes a corrosion product film which deposits on a part of the metal surface and a corrosion process. The χ^2 parameter of fitting was around

7×10^{-4} indicating an appreciable quality of fitting and therefore confirming the applicability of the used model. The fitting lines are shown on the EIS spectra of the samples after 2 hours of immersion (Fig. 14). During 2 hours of immersion the polarisation resistance increased from around 1500 to 3000 Ohm cm² and

from 1000 to 2500 $\Omega \cdot \text{cm}^2$ on Z and ZM cut edges, respectively. At longer immersion time (ca. 6 h) the same resistances further increased to 5000 $\Omega \cdot \text{cm}^2$ and 3300 $\Omega \cdot \text{cm}^2$. The corrosion products resistance grows slightly during 0.5–2 h of immersion on the Z sample from 160 to 510 $\Omega \cdot \text{cm}^2$ and on the ZM it stays

around $300-280 \,\Omega \cdot cm^2$. However, at longer immersion (ca. 6 h) this resistance drops at both Z and ZM cut edges.
